インフラの劣化調査法について

「インフラ」とは、インフラストラクチャーの略語であり、トンネルやダムなどの土木構造物のことである。現在、日本の多くのインフラは築50年を経過しており、劣化調査の怠りは笹子トンネル事故のような突然の壁面崩壊をもたらし、市民を巻き込む大きな事故につながる。そこで、容易に実施可能なインフラの劣化調査法を検討した。

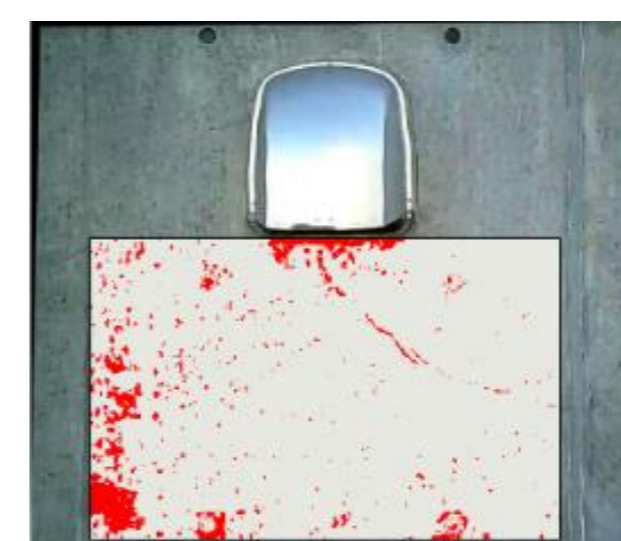
輝度値を利用してひび割れ部分を抽出した。赤い部分がひび割れを示し、その長さや幅を画像上で測定できる。すが、ひび割れ以外の部分も赤くなっている。ひび割れ部分は線状になっているので、判別できる。

(c-2) 新体育館1階上方壁面 (オルソ画像によるひび割れ調査画像)

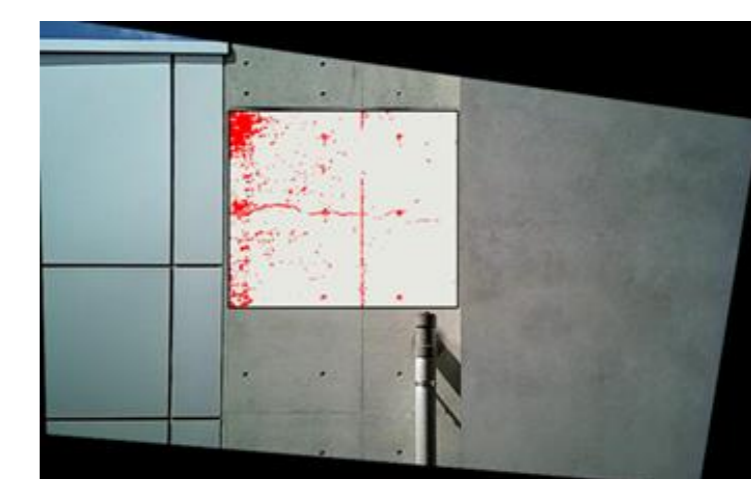
(d-2) C棟2階壁面 (オルソ画像によるひび割れ調査画像)
